## Evaluation of the performance of the wastewater treatment plant in a community in the province of Cotopaxi

### Evaluación del desempeño de la Planta de Tratamiento de Aguas Residuales en una comunidad de la provincia de Cotopaxi

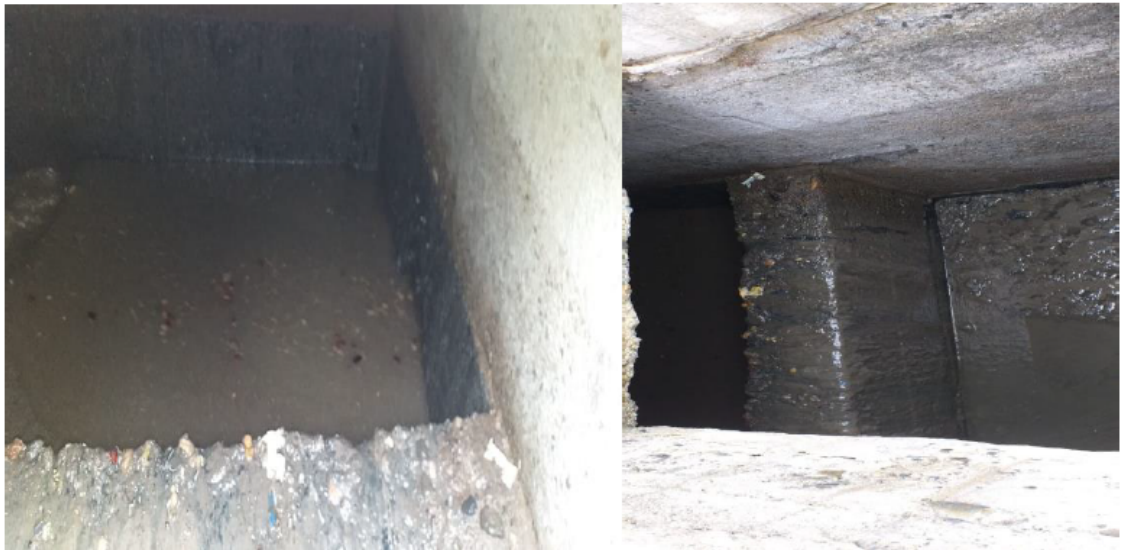
**Figure 2.** Visual diagnosis of the settler

Defects have been observed in the maintenance of this unit, as can be seen in Figure 2. The accumulation of debris due to these defects is affecting the functional efficiency of the structure.

A complete structural repair of the WWTP is recommended, focusing especially on the waterproofing of the septic tank and the removal of the FAFA stone bed to avoid blockages in the pipes. In addition, it is proposed to implement a periodic maintenance plan to ensure the proper functioning of all plant units.

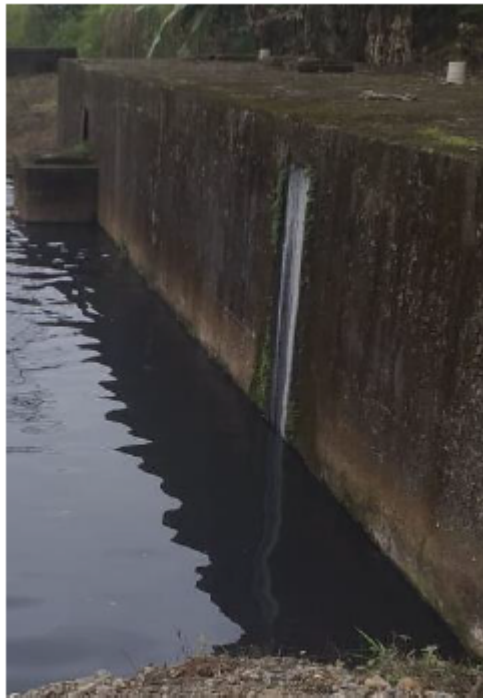
**Figure 3.** Seepage in the septic tank

Figure 3 shows leaks in the wall adjacent to the sludge drying bed, caused by the water pressure accumulated in this unit. In addition, Figure 4 shows suspended solids that have passed through the settler,

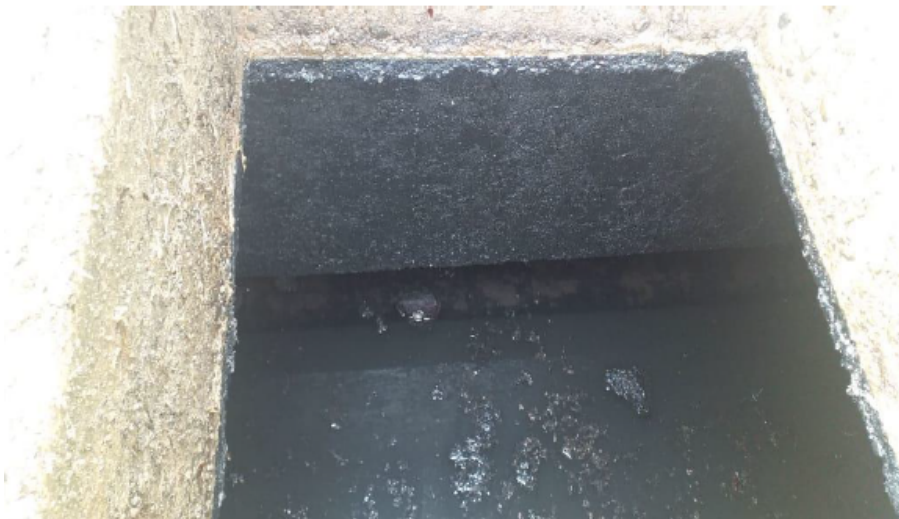
**Figure 4.** Diagnosis of the septic tank

as well as the water level that is about to reach the edge of the slab of this structure, which, according to plant operators, often causes the water to overflow.

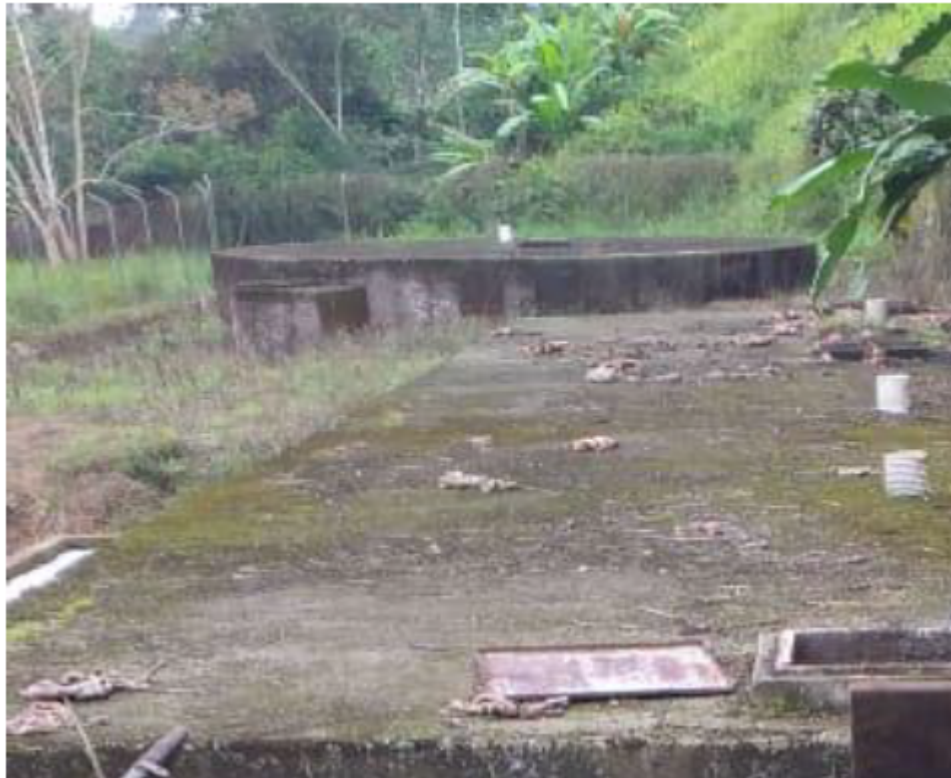
**Figure 5.** FAFA diagnosis

This structure is the cause of the failures in the previous units, since it is located at a higher level than the septic tank, as shown in Figure 5. This arrangement prevents the water from rising and completing its process before being discharged into the nearby freshwater body, the Piñanato River.

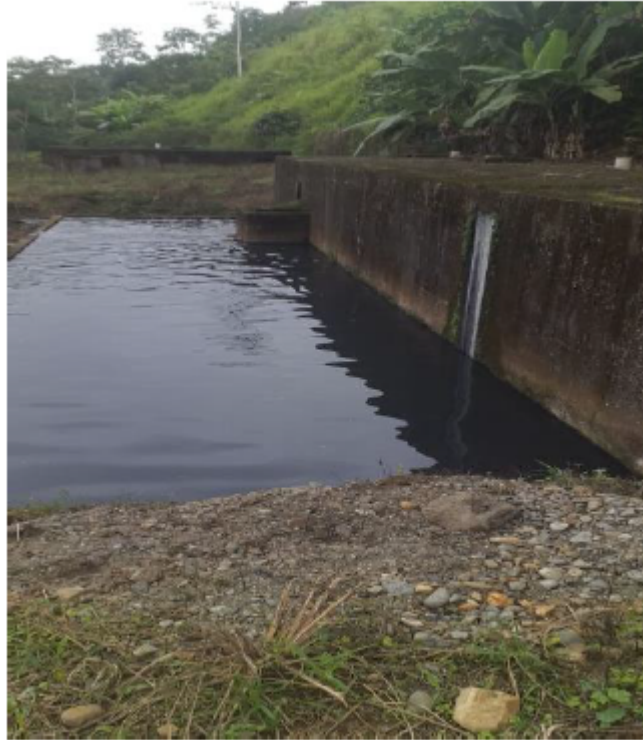
**Figure 6.** Diagnosis of the sludge drying bed

This structure is as deteriorated as the others in the WWTP, as shown in Figure 6, which prevents it from performing its function effectively. The water coming from the septic tank causes the sludge to stagnate, keeping it always saturated and preventing this infrastructure from adequately performing the task for which it was designed.
